Trouble shooting for ink over spraying

artis 2100U

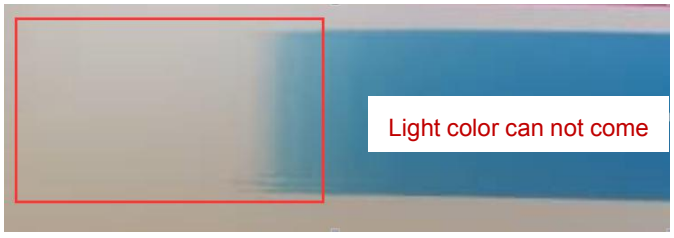
2) Bad result:
Ink over spraying / light color can not come on

Normal Result

Ink over spraying

Light color can not come

3. According the printing result to do Ink following

1) if only single ink over spraying ,
for example"Black"

Solution:
Suck black ink from damper around 3 ml.

2) if all ink over spraying

Solution:
Suck waste ink from waste ink tube around 5 ml.
